Hotbox Test R-value Database

Straw Bale Wall Technology

Description Of Wall

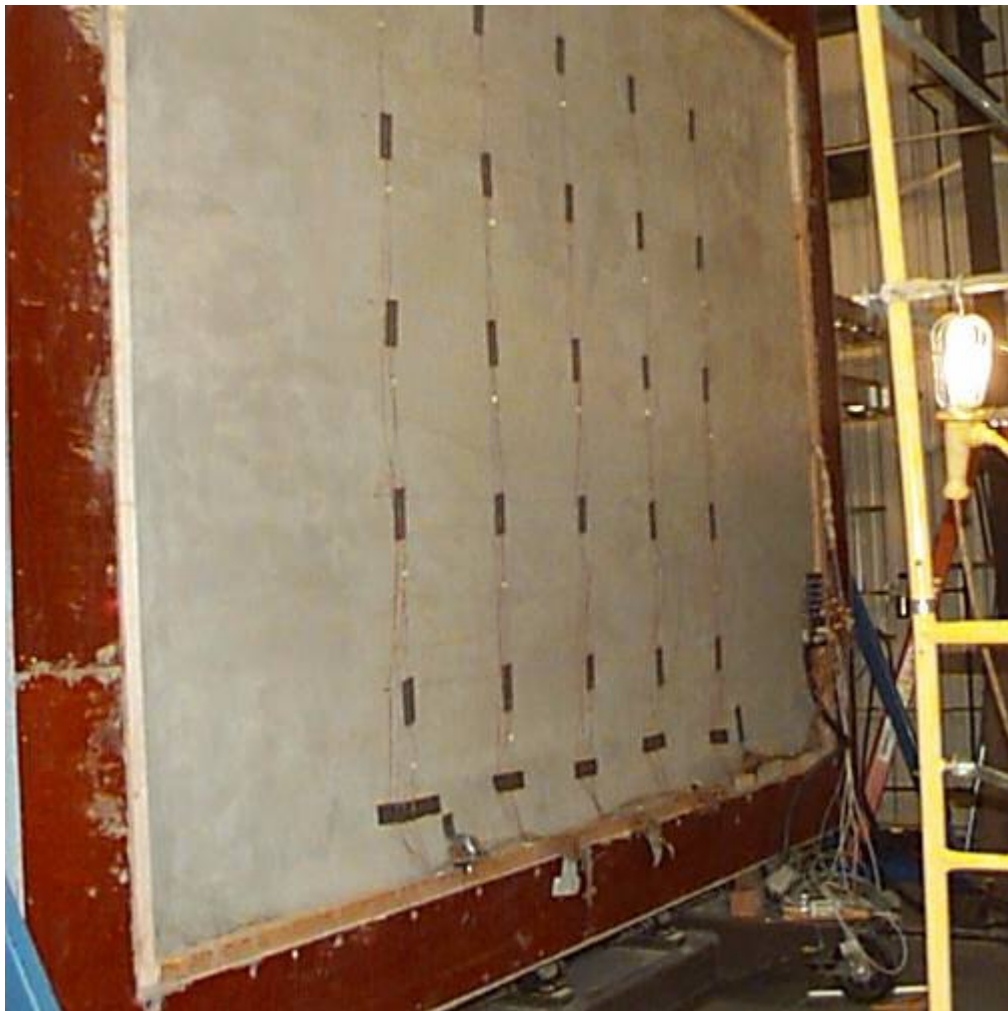
The new test was designed to overcome problems that distorted straw bale's thermal performance in 1996 test. Several nationally known straw-bale home builders oversaw construction of the walls and the testing. It was decided that an 2.44 m X 2.44 m (8'X8') load-bearing wall would be built of straw-bales with stucco on one side of the wall and dry wall on the other. The bales were individually identified and the density of each was recorded. Because straw-bales are not uniformly shaped or sized, it was necessary to determine dimensional and structural similarity. An effective bale length of 0.945 m (3.1') was established by determining the mean of ten bales. The twenty-one similar straw bales were chosen and half bales were created from three to facilitate the construction. Bales were 19" (480 mm) wide and stacked flat. After being plastered on both sides, the wall was allowed to dry for almost two months (to 13% moisture content). After a two-month drying-out period, the wall was put in the test chamber.

The interior temperature was raised to 70°F, while the exterior temperature remained at 0°F for two weeks, in order to reach steady-state heat flow conditions. After this two-week period, the 19-inch wall had an R-value of 27.5, or 1.45 per inch.

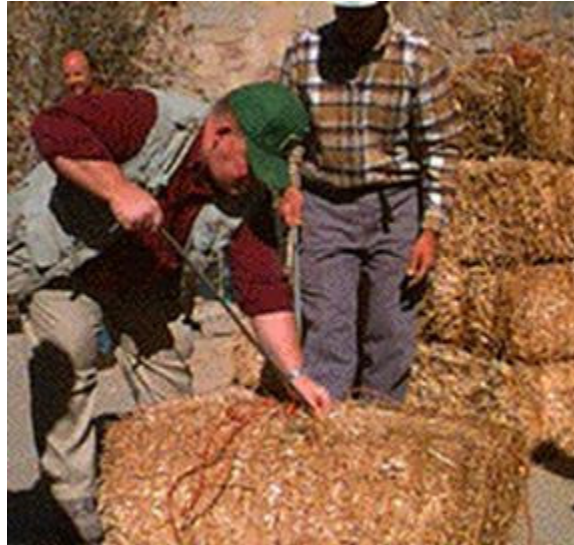
Several special tools were made to construct the wall. A bale needle made of 6.35 x 10 -3 m (1/4") metal rod pounded flat and then grounded to a point at one end and then drilled with two holes for eyes was made.
